National  
Wood Flooring  
Association

# PROBLEMS, CAUSES AND CURES

OF HARDWOOD FLOORS

*2<sup>nd</sup> Edition*

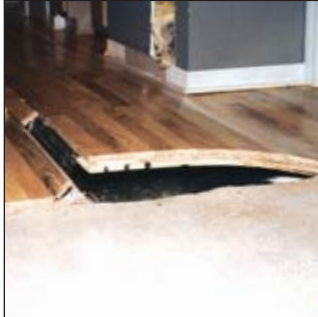
## BUCKLING

Excessive expansion causing the wood flooring to release from the subfloor.

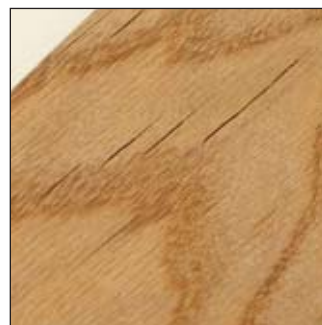
## CHECKS

Separations of the wood that normally occur across or through the annual rings.

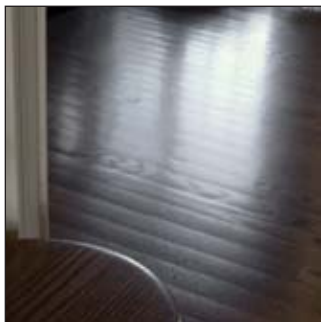
## CROWNING

The center of the pieces of flooring appears to be higher than the edges.

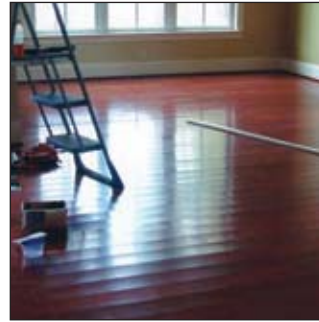
## CUPPING

Cupping occurs across the width of the individual pieces of flooring. The edges are high and the center is lower. It generally develops gradually.

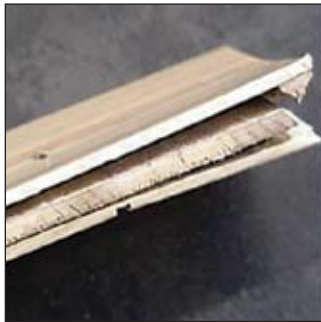
## DELAMINATION

The separation of a layer from an adjoining one within a piece of engineered wood flooring.

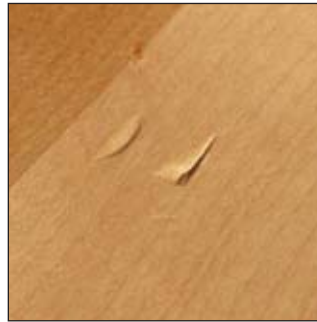
## DENTS

A crushed spot in the wood.

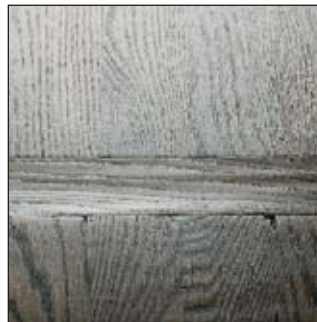
## DISH OUT

Areas on the wood floor where softer parts of the wood appear to have been sanded or hollowed out more than other areas. It is more evident in wood species that exhibit pronounced spring (soft) and summer (hard)

Uneven wear between segments of annual rings. (For "Dishout," see page 8)

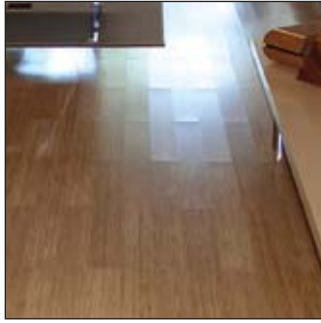
## ENDLIFTING

Ends of engineered wood flooring boards appear raised.

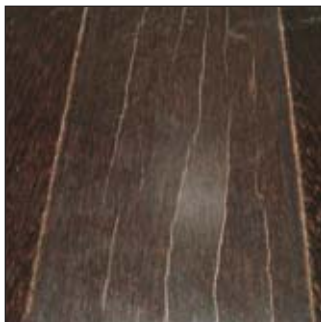
## FACE-CHECKING

Long cracks in the veneer that run along the length of the board in engineered flooring.

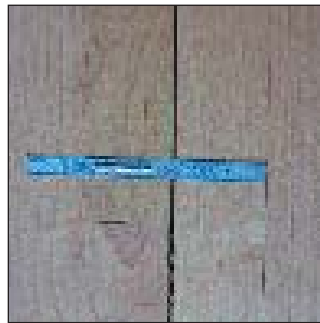
## GAPS, ABNORMAL

Gaps in the floor that remain with seasonal change. If some boards appear glued together by the finish on the surface, see "Sidebonding" on page 18.

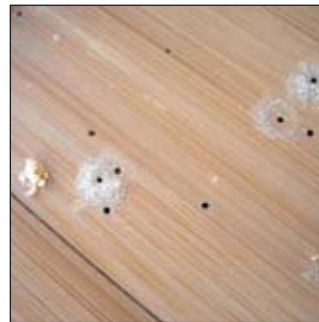
## INSECTS

A sagging surface or small fresh holes surrounded by a halo of fine dust or small holes appearing in the surface of the flooring.

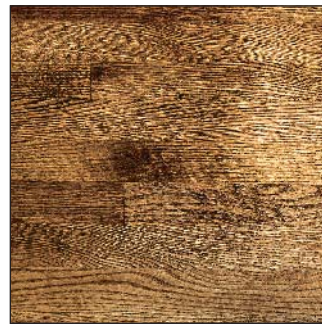
## PICTURE FRAMING (“HALO”)

The edges of the room appear to be a slightly different color than the rest of the room.

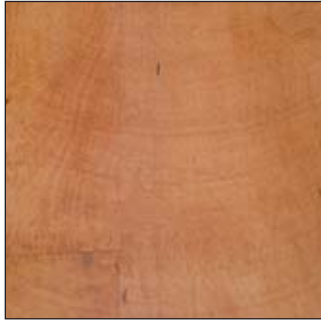
## SANDING MARKS

Sanding imperfections seen as scratches, drum marks, dishouts, sanding scratches, swirl marks and stop marks.

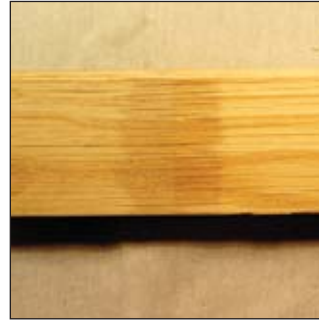
## STICKER/STICK STAIN

Light brown marks that appear on the wood flooring surface. They occur across the width of the strip, measure ¾ to 1 inch wide and occur about every 12 to 24 inches across the face of the floor. (In photo shown, right side of

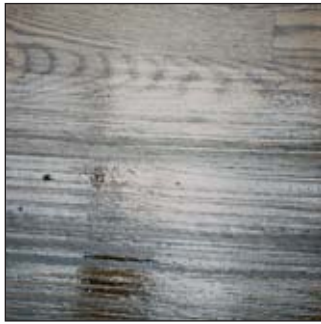
## APPLICATOR STREAKS

After the floor dries, marks still are visible from the path of the applicator. It usually is associated more with water-based finishes than other types of finishes, although it may affect all other finish types, as well.

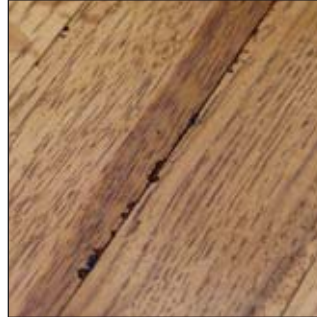
## BLEED BACK

Bleed back of oil-based stain occurs when excess stain seeps up after it has been applied on open grain or from the gaps between boards.

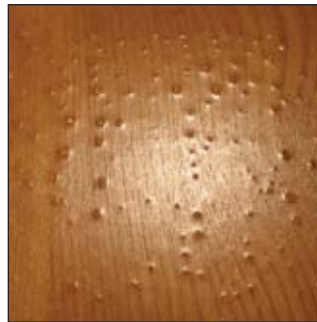
## BUBBLES

Dried bubbles are visible on the surface of a finish.

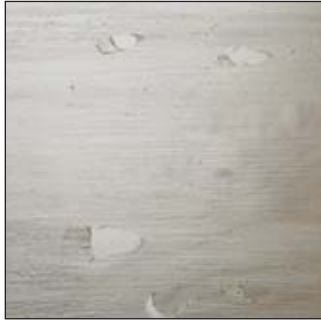
**CHIPPING**

Dried finish separates from the surface in the form of flakes or chips.

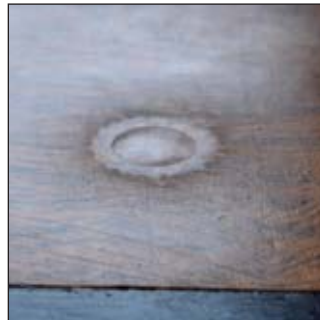
**CRATERING**

The formation of small bowl-shaped depressions in the finish.

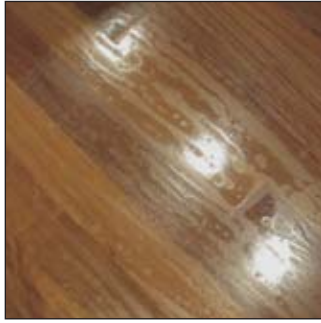
## CRAWLING

Defect in which the finish recedes from small areas of the surface, leaving them apparently uncoated. (Photo also shows fish eyes.)

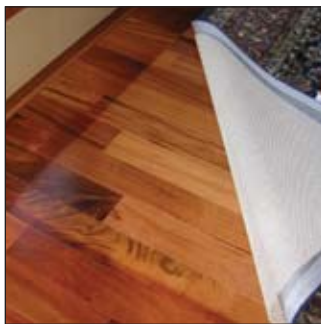
## DISCOLORATION

The floor changes color (darkens or lightens) over time. Some areas may change color more than others.

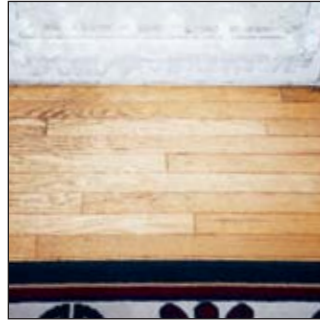
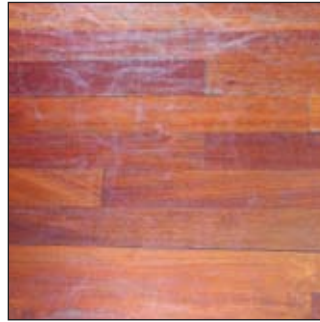
## EARLY FINISH WEAR

The appearance of too much (premature) wear on a relatively new finish.

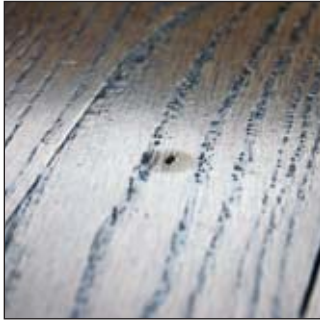
## FISH EYES

**What it is:** Defect that manifests itself by the crawling of wet finish into a recognized pattern resembling small “dimples” or “fish eyes.” They can measure up to about 1 inch in diameter. You may find a tiny particle in the middle

of some fish eyes, which may be the cause for some to form.

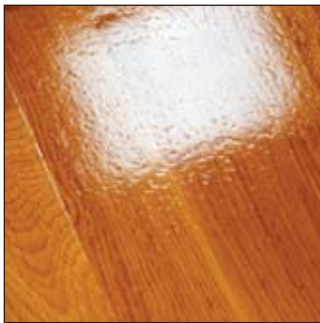
## ORANGE PEEL

**What it is:** The surface of the finish has a texture that resembles an orange peel.

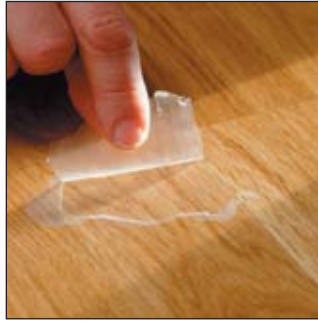
## PEELING

**What it is:** The finish releases from the wood floor or previous finish coat.

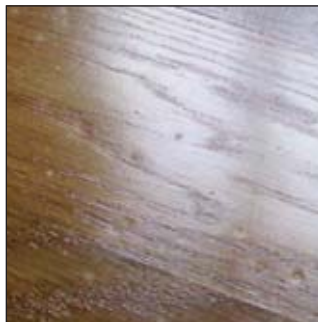
## PIN HOLES

A defect similar to fish eyes, but very, very small.

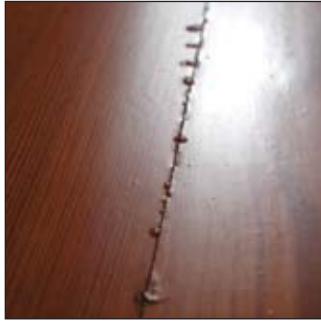
## POLY BEADS

Beads or “BBs” of finish that form along the edges of the flooring pieces. They can be soft and sticky when first formed, but will become quite hard if left undisturbed.

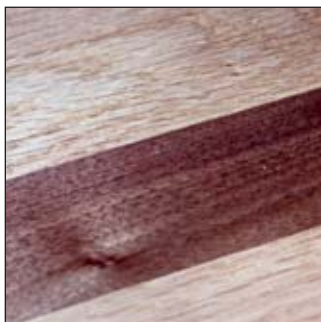
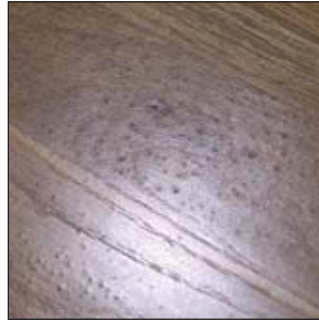
## ROUGHNESS/GRAIN RAISE

The surface of the wood floor is rough to the touch.

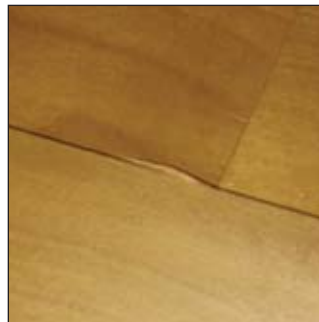
## SIDEBONDING

With sidebonding, the edges of the individual boards are “glued” together by the finish. It can occur with all types of finish, although it happens more frequently with water-based products. (Panelization and sidebonding may

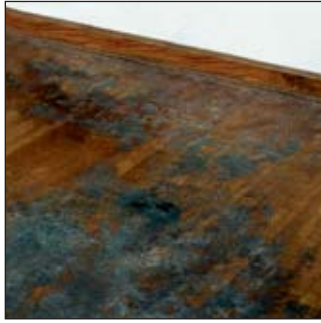
## STAINS

### What it is:

Discoloration on one area of the floor.

### Cause:

- Spilled liquids.
- Pet stains (shown at left).
- Residue from improper cleaners.
- Continual moisture leading to mildew

(black), decay (brown/white) or alkaline conditions (white).

Cloudy surface finish can be fixed by lightly rubbing with a proper cleaner and buffing, although some stains require abrading/screening and re-coating. Pet stains frequently require total board replacement. For moisture problems, eliminate the source of moisture, then evaluate the condition of the flooring before deciding on corrective action.

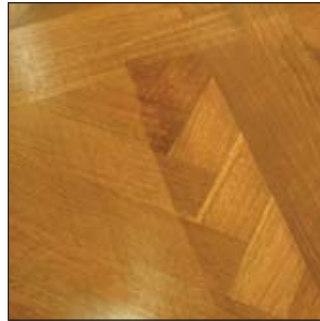
## TANNIC ACID DISCOLORATION/PULL/BLEEDING

### What it is:

Tannic acid discoloration/pull (also sometimes called tannic acid bleeding) is a dark/greenish/brown discoloration that may occur with a freshly applied coat of waterborne floor finish on a wood species containing high

- The coating and the discoloration needs to be removed down to bare wood in the affected area before re-coating. Small areas can be taken care of using a sharp scraper and sandpaper, but when the discoloration is widespread across the floor, it is often best to resand the floor.
- First apply a specially designed sealer (as recommended by the manufacturer of the finish) for reducing/preventing tannic acid discoloration. Apply this consistently, without leaving heavy spots or thin spots.
- When the sealer is abraded, abrade it lightly, moving along swiftly without abrading through the sealer coat.
- Apply waterborne finish coats evenly without leaving puddles of finish in one area for too long, as puddles may cause an adverse reaction with tannic acid in the wood.
- A thinner first coat of finish will reduce the likelihood of adverse reactions with tannic acid in the

wood. Subsequent coats may be applied as thick as recommended by the manufacturer.

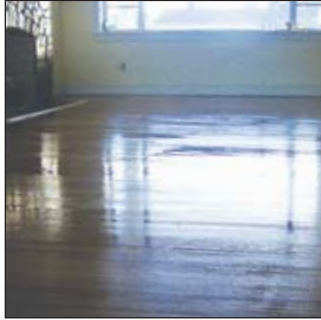
## UNEVEN SHEEN LEVELS (see also “Applicator Streaks”)

### What it is:

The sheen of the finish is inconsistent.

### Cause:

- Insufficient mixing of finish prior to application.
- Uneven sanding.
- Uneven finish thickness.
- Illusion caused by

Abrade/screen and recoat. If lighting is the cause, discuss with the customer the reasonable inspection position for looking at a hardwood floor—from a standing position under normal lighting conditions.

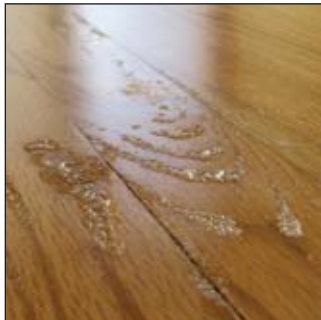
## WRINKLING

### What it is:

Once the finish starts to dry, it takes on the appearance of the skin of a dried prune. Wrinkling may happen with all types of floor finish, but is more likely to occur with oil-modified polyurethane.

- Small affected areas should be scraped down carefully to a dry surface, allowed to dry/cure further and the transition sanded smooth before touching up and recoating.
- When large areas are affected, it is best to resand the floor before recoating (be careful with sanding dust from fresh coats of oil-modified polyurethane, which is extremely combustible).
- When applying finish, use the recommended spread rate for the product being applied and be sure that the ambient temperatures of both the floor and air are at the recommended temperature. (Note that hardwood floors do not heat up instantly when the heat gets turned on; it is best to turn up the heat a few days before starting a job. Cold crawl spaces can be a serious problem.)
- If needed, allow more dry/cure time between coats.
